Manhole Inspection Summary

Manhole # S29GG1015MH

Insp Date: **4/13/07 10:17 AM**

Location Address: **3939 KESWICK AVE**

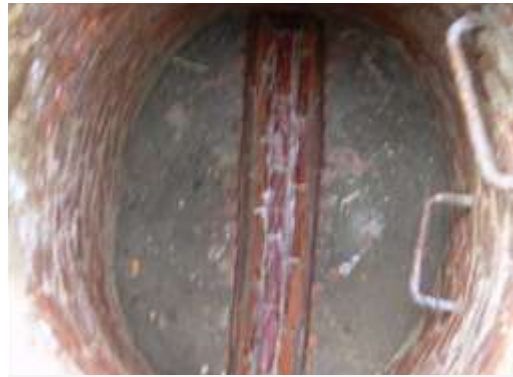
Top View

Steps Count: **2** Missing: **0** ☒ **Corroded**

Surcharge ☒ **Evidence Of Surcharge** Depth: **1** (ft.) ☐ Active Surcharge Present

Corroded steps. Evidence of surcharge - Bench debris.

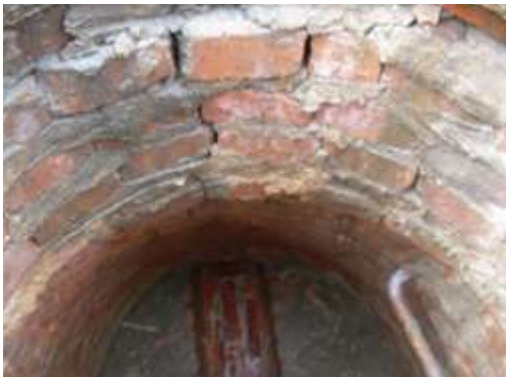
Defect

Condition: ☐ Sound ☐ Cracked ☐ Root Intrusion ☐ Loose Brick ☒ **Deteriorated**

Infiltration: ☐ None ☒ **Joint** ☐ Cracks ☐ Mortar ☐ Roots ☒ **Wall**

Adjustment deterioration and infiltration.

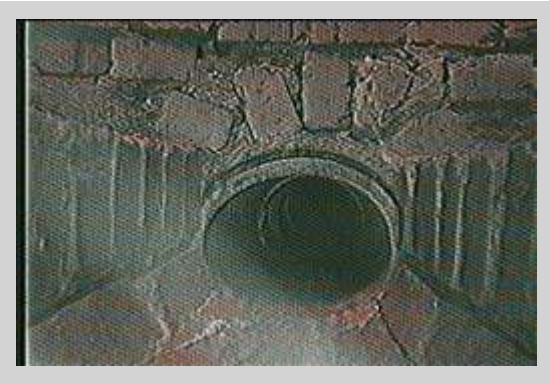
8 in. Circular Gravity Sewer Pipe Out @ 12 O'Clock

Barrel deterioration and infiltration. Channel deterioration.

Infiltration: **Evidence** Pipe Seal Cond: **Unknown**

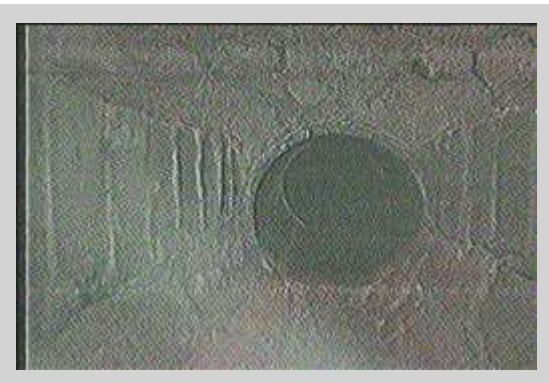
8 in. Circular Gravity Sewer Pipe In @ 6 O'Clock

Barrel deterioration and infiltration. Channel deterioration.

Infiltration: **Evidence** Pipe Seal Cond: **Cracked**
